**TARGETED SITE INVESTIGATION REPORT  
SAN PABLO ASSEMBLAGE SITE  
3706 SAN PABLO AVENUE  
EMERYVILLE, CALIFORNIA**

**CONTRACT NO. 11-T1035  
STATE OF CALIFORNIA  
ENVIRONMENTAL PROTECTION AGENCY  
DEPARTMENT OF TOXIC SUBSTANCES  
CONTROL – REGION 2  
700 HEINZ AVENUE  
BERKELEY, CALIFORNIA 94710-2737**

**APRIL 20, 2012**

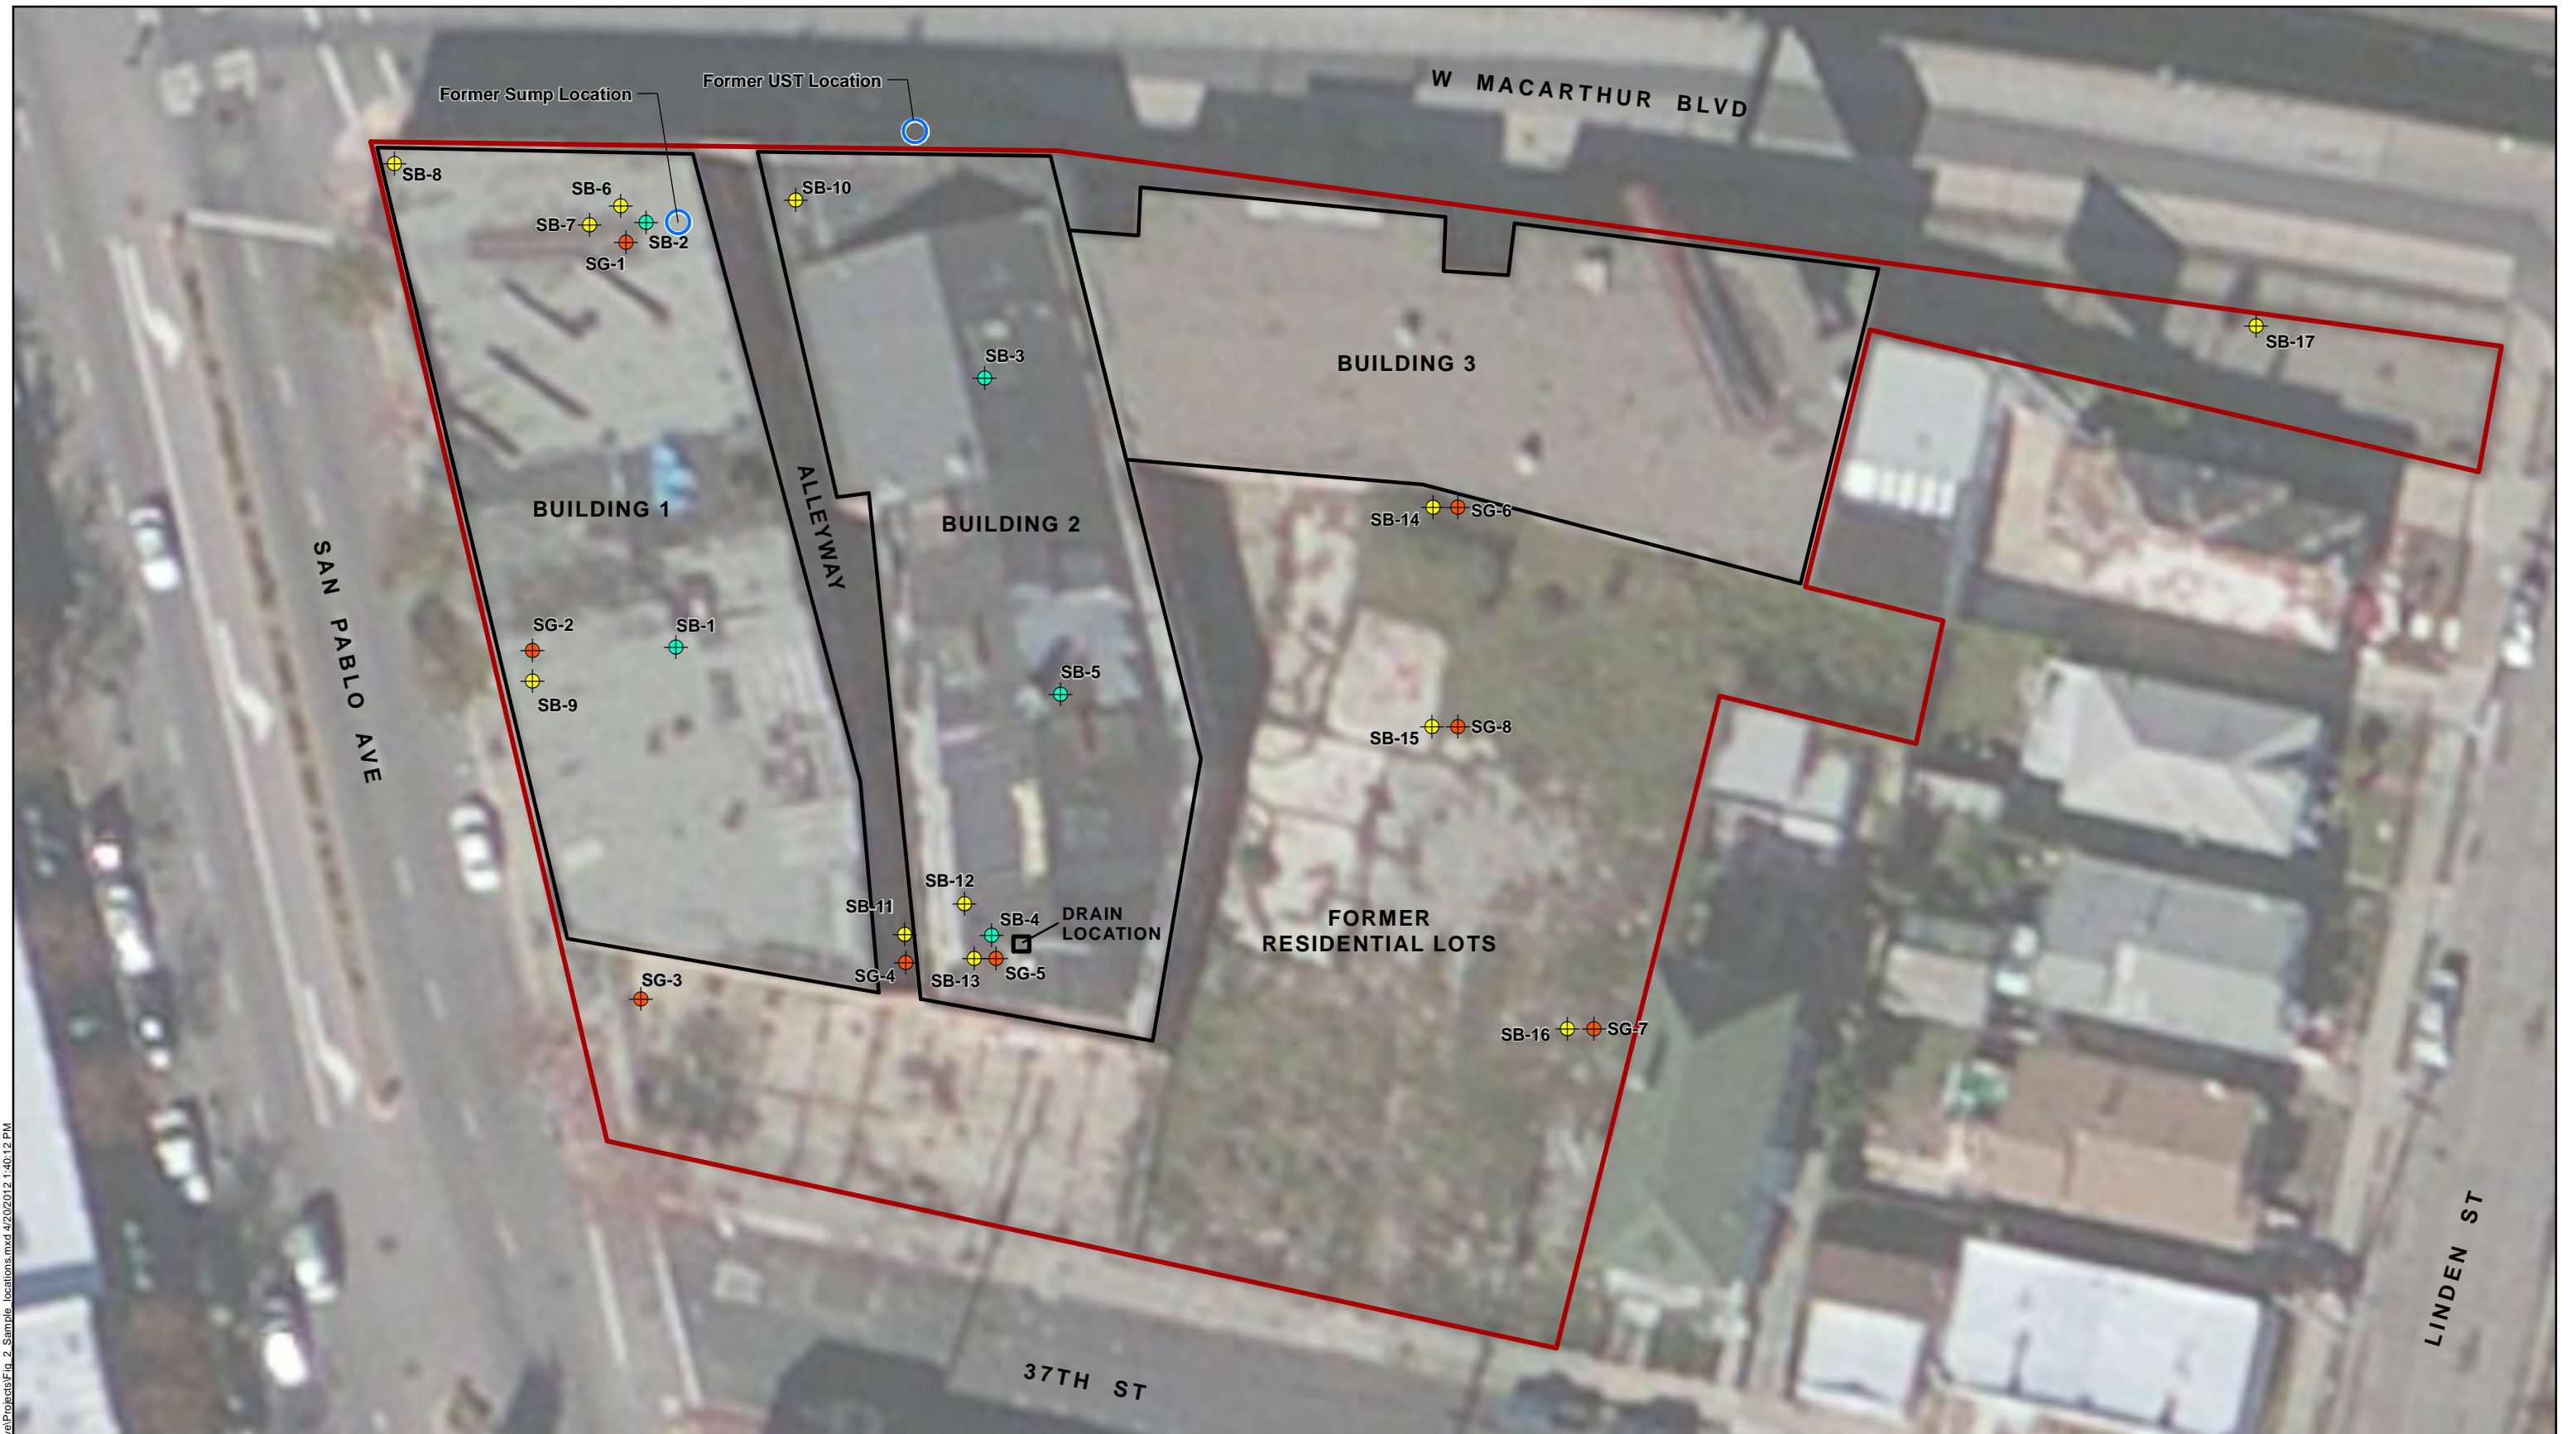
- ◆ Soil Gas Sample Location
- ◆ Soil and Groundwater Sample Location
- ◆ Previous Investigation Sample Locations (2010)
- Former Sump/UST Location
- Subject Property
- Building Outline

Note: Soil samples were collected at 2 feet and 5 feet bgs

049-0951-005-01; 049-0951-006-01; 049-0951-007 and 012-0951-011—totaling approximately 1 acre. A Site Plan, including sample locations, is presented as Figure 2.

Soil borings were installed by Vapor Tech Services of Berkeley, California, using direct-push technology (DPT), or by hand auger at twelve sample locations, SB-6 to SB-17 (Figure 2). During advancement of the DPT boreholes, a continuous core was collected at each location using 5-foot-long acetate sleeves. Samples collected for TPH-g were collected using gas-tight EnCore™ samplers. Samples for TPH-d, TPH-motor oil (TPH-mo) and metals were collected either in 4-ounce glass jars, stainless-steel sleeves, or in the acetate sleeves that were cut at the desired sampling interval and sealed with Teflon™ sheeting and end-caps. All borings were logged in accordance with the Unified Soil Classification System. Laboratory reports, data validation reports, and chain-of-custody forms are provided in Appendix A. Boring logs are included as Appendix B.

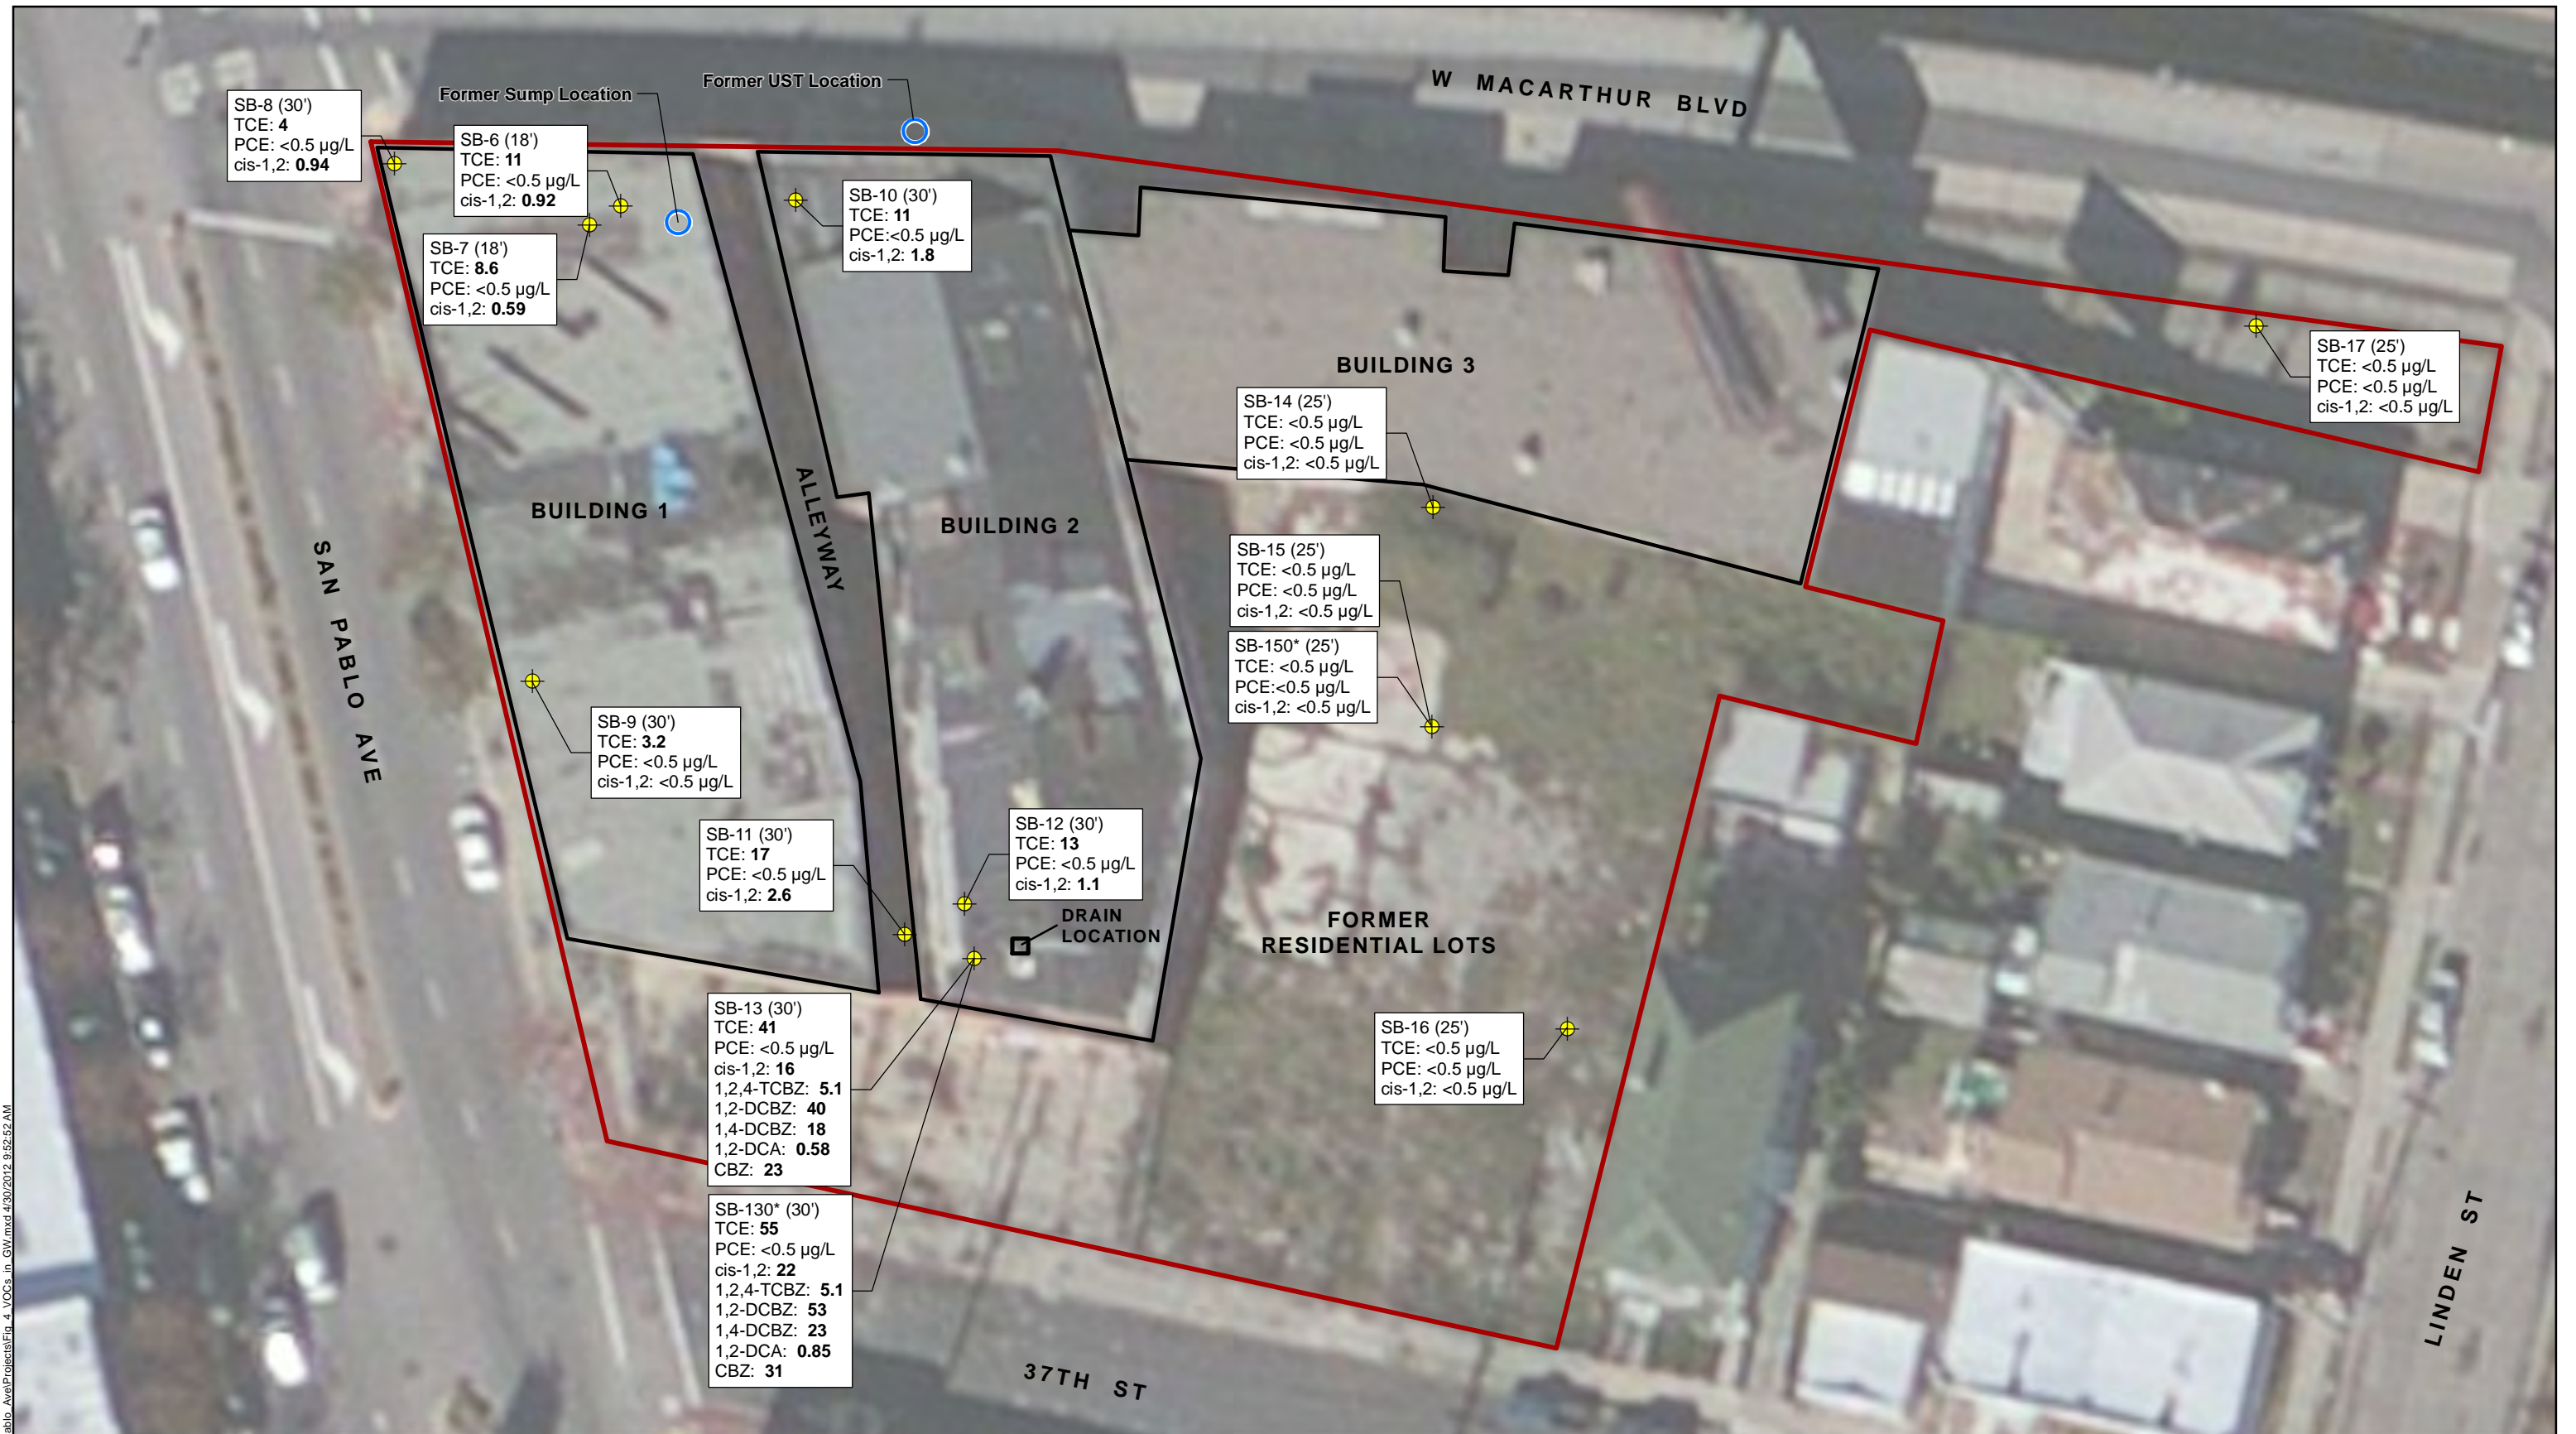
**FIGURE 4**

SB-8 (30')  
TCE: **4**  
PCE: <0.5 µg/L  
cis-1,2: **0.94**

SB-6 (18')  
TCE: **11**  
PCE: <0.5 µg/L  
cis-1,2: **0.92**

TCE contamination of shallow groundwater exceeds MCLs at two areas of the Site. Prior to initiating any groundwater remedial action, additional grab-groundwater sampling is recommended to better assess concentrations in groundwater, determine the lateral extent of the shallow groundwater plume, and determine whether contamination is migrating off Site. Based on the results of the supplemental groundwater investigation, there are two potential remedial approaches. If additional soil and/or soil gas work indicates there is no source of TCE in soil and TCE concentrations are consistent with those observed in this investigation and the TCE groundwater plume does not appear to be migrating offsite, then monitored natural attenuation (MNA) may be a viable option until established groundwater goals (MCLs) are achieved. This will require the installation of permanent monitoring wells, which must be protected during construction and accessible after redevelopment.

If TCE concentrations are significantly greater than MCLs, then in situ groundwater treatment may be warranted such as enhanced biodegradation using hydrogen release compound or emulsified oil. It is also possible that source removal may be a feasible alternative, if TCE source areas are identified on site. Groundwater analytical results indicate that limited reductive dechlorination of TCE is occurring (Section 6.0) as cis-1,2-DCE results correlate well with TCE results. Cis-1,2-DCE is a breakdown product when TCE undergoes degradation. Consequently, enhanced in-situ biodegradation may be a viable remedial measure at this site, based on the analytical data currently available. Since grab groundwater data are typically considered screening-level data, groundwater monitoring well installation should be considered after the

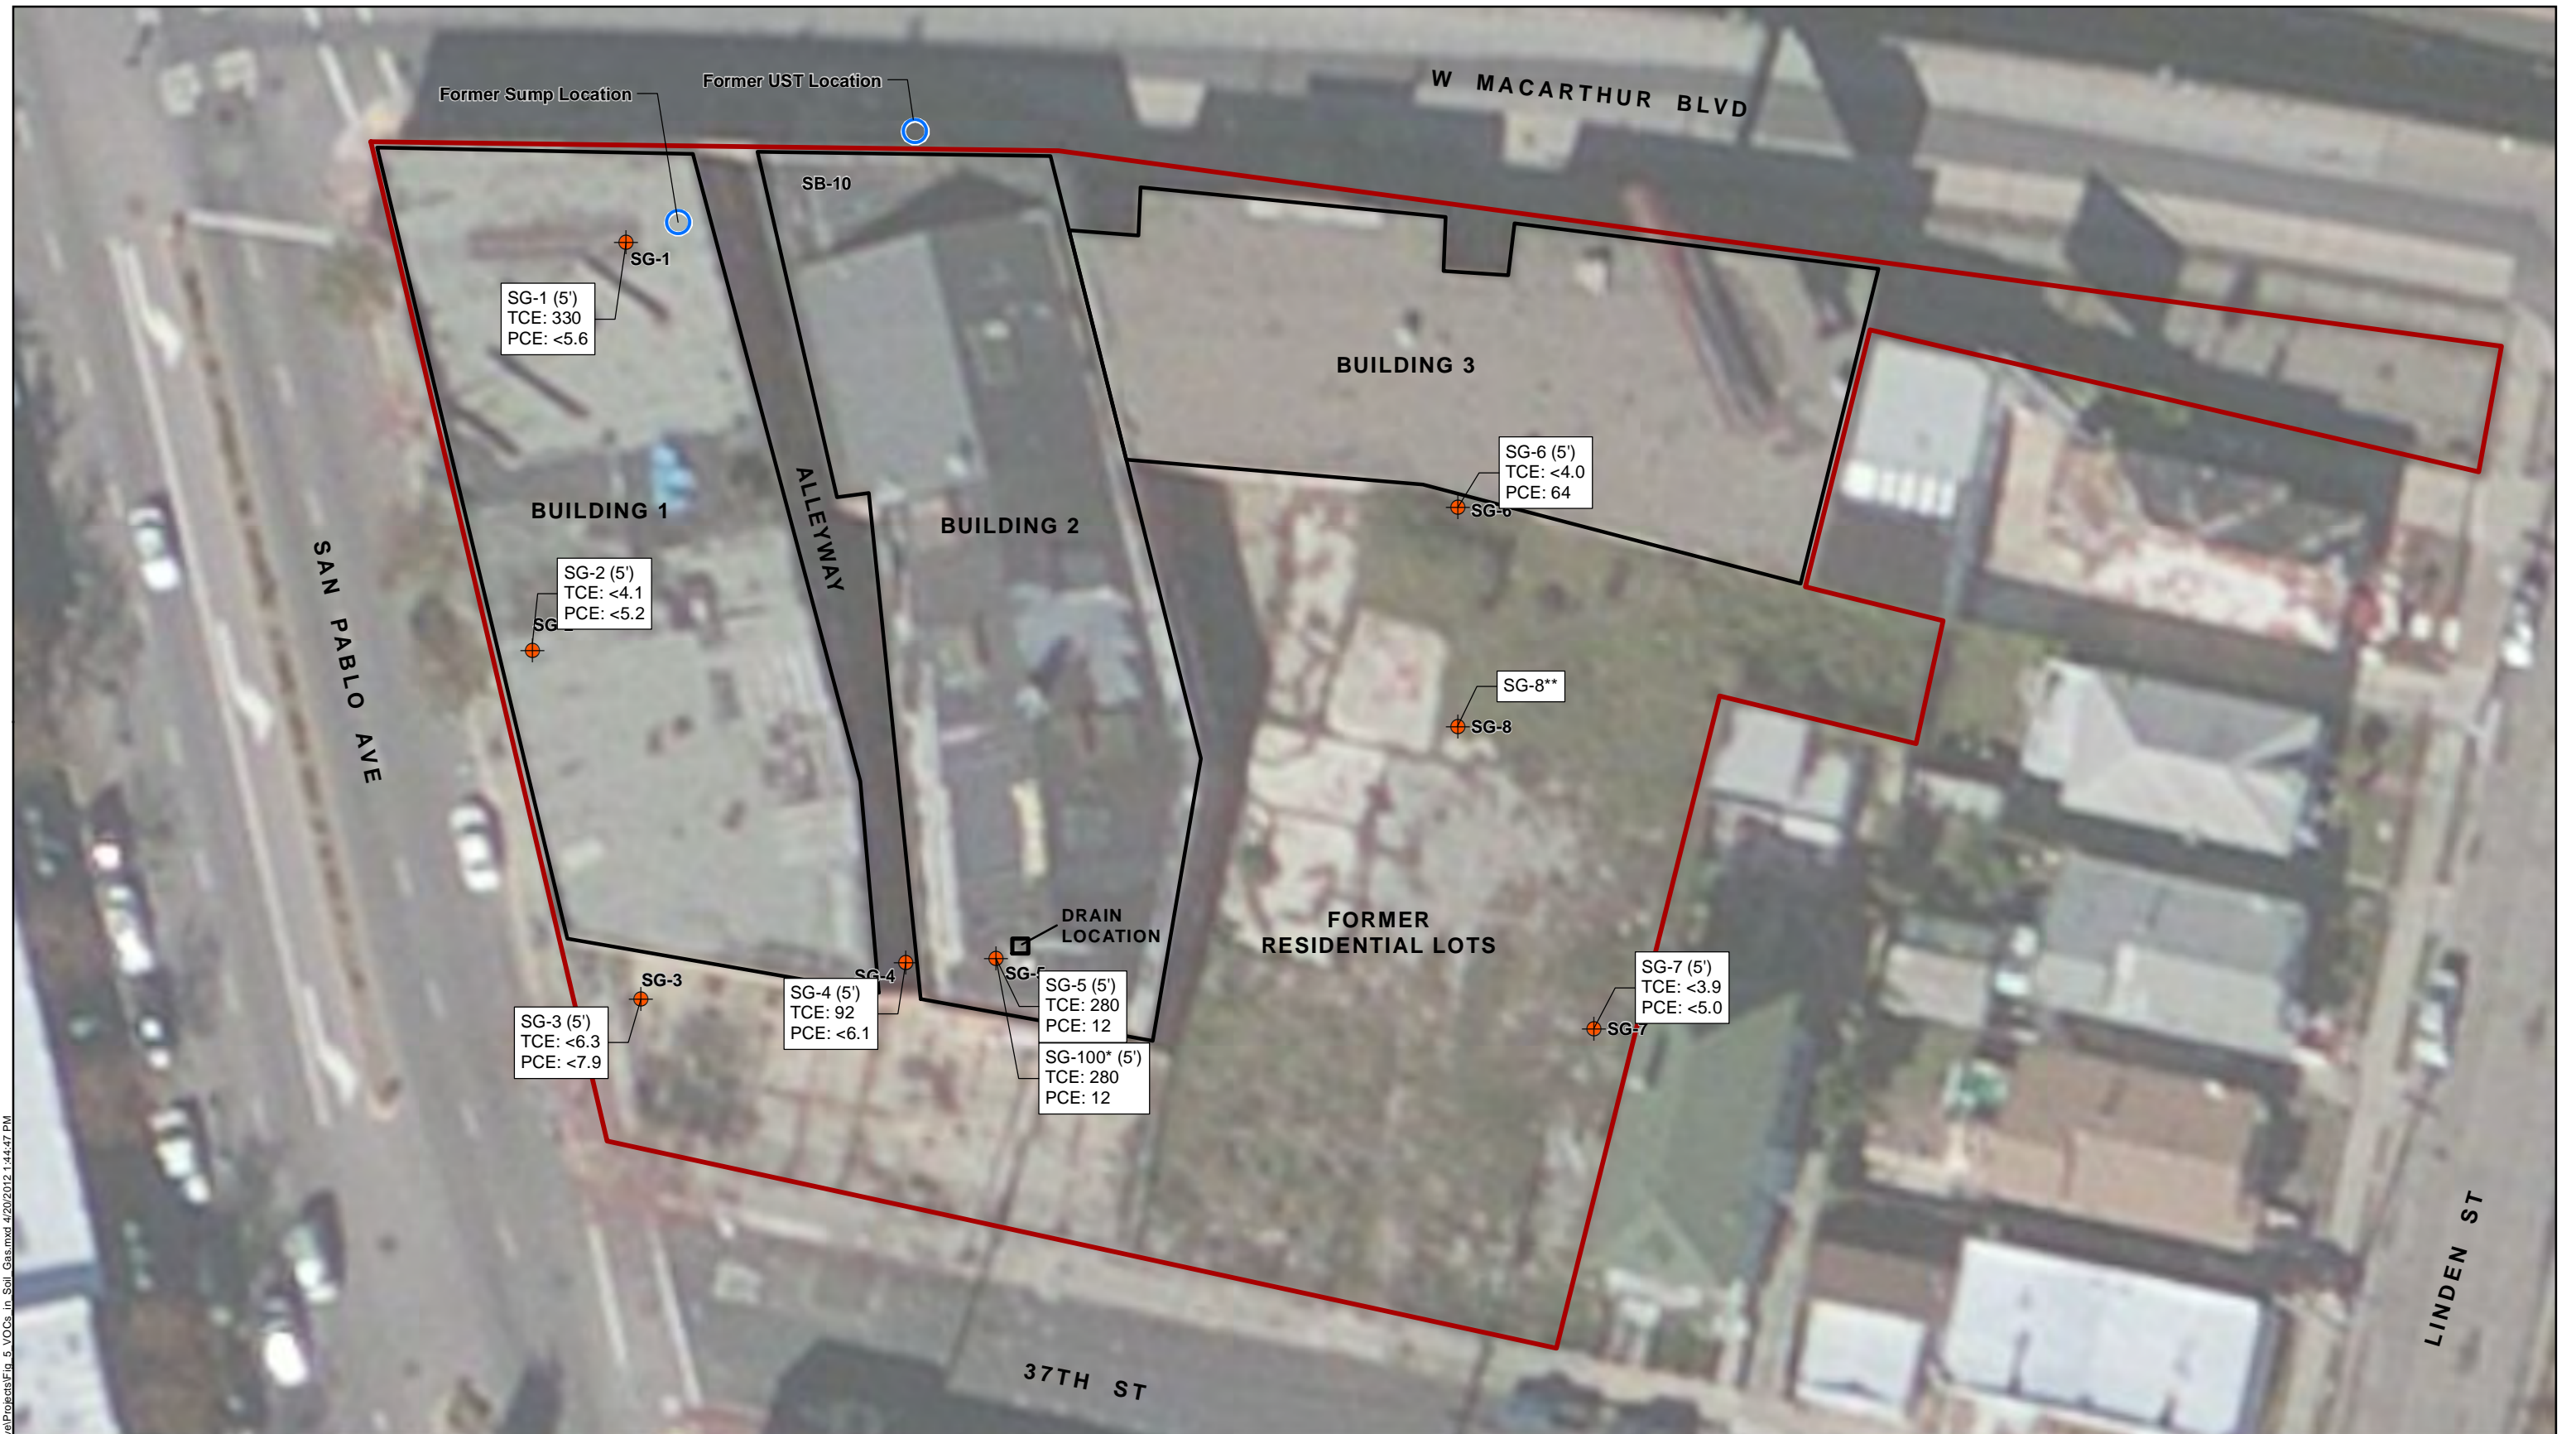
- ⊕ Soil Gas Sample Location
- Former Sump/UST Location
- Subject Property
- Building Outline

TCE soil gas data indicate the potential for a soil source in the area of or upgradient of SG-5, and also in the area of SG-1. Consequently, it is recommended that additional investigation, either soil gas sampling and/or soil sampling, be conducted at step-out locations in these areas. Additional investigation would also better delineate the lateral and vertical extent of contamination in these areas and reduce uncertainty associated with redeveloping the Site. Depending upon the nature of the redevelopment, it may be necessary to excavate soil in these areas.
