PHASE I ENVIRONMENTAL SITE ASSESSMENT

**3706 San Pablo Avenue and 1066-1072 37th Street,
Emeryville, California and
1025 W. MacArthur Boulevard
Oakland, California**

01-EMER-001

November 20, 2009

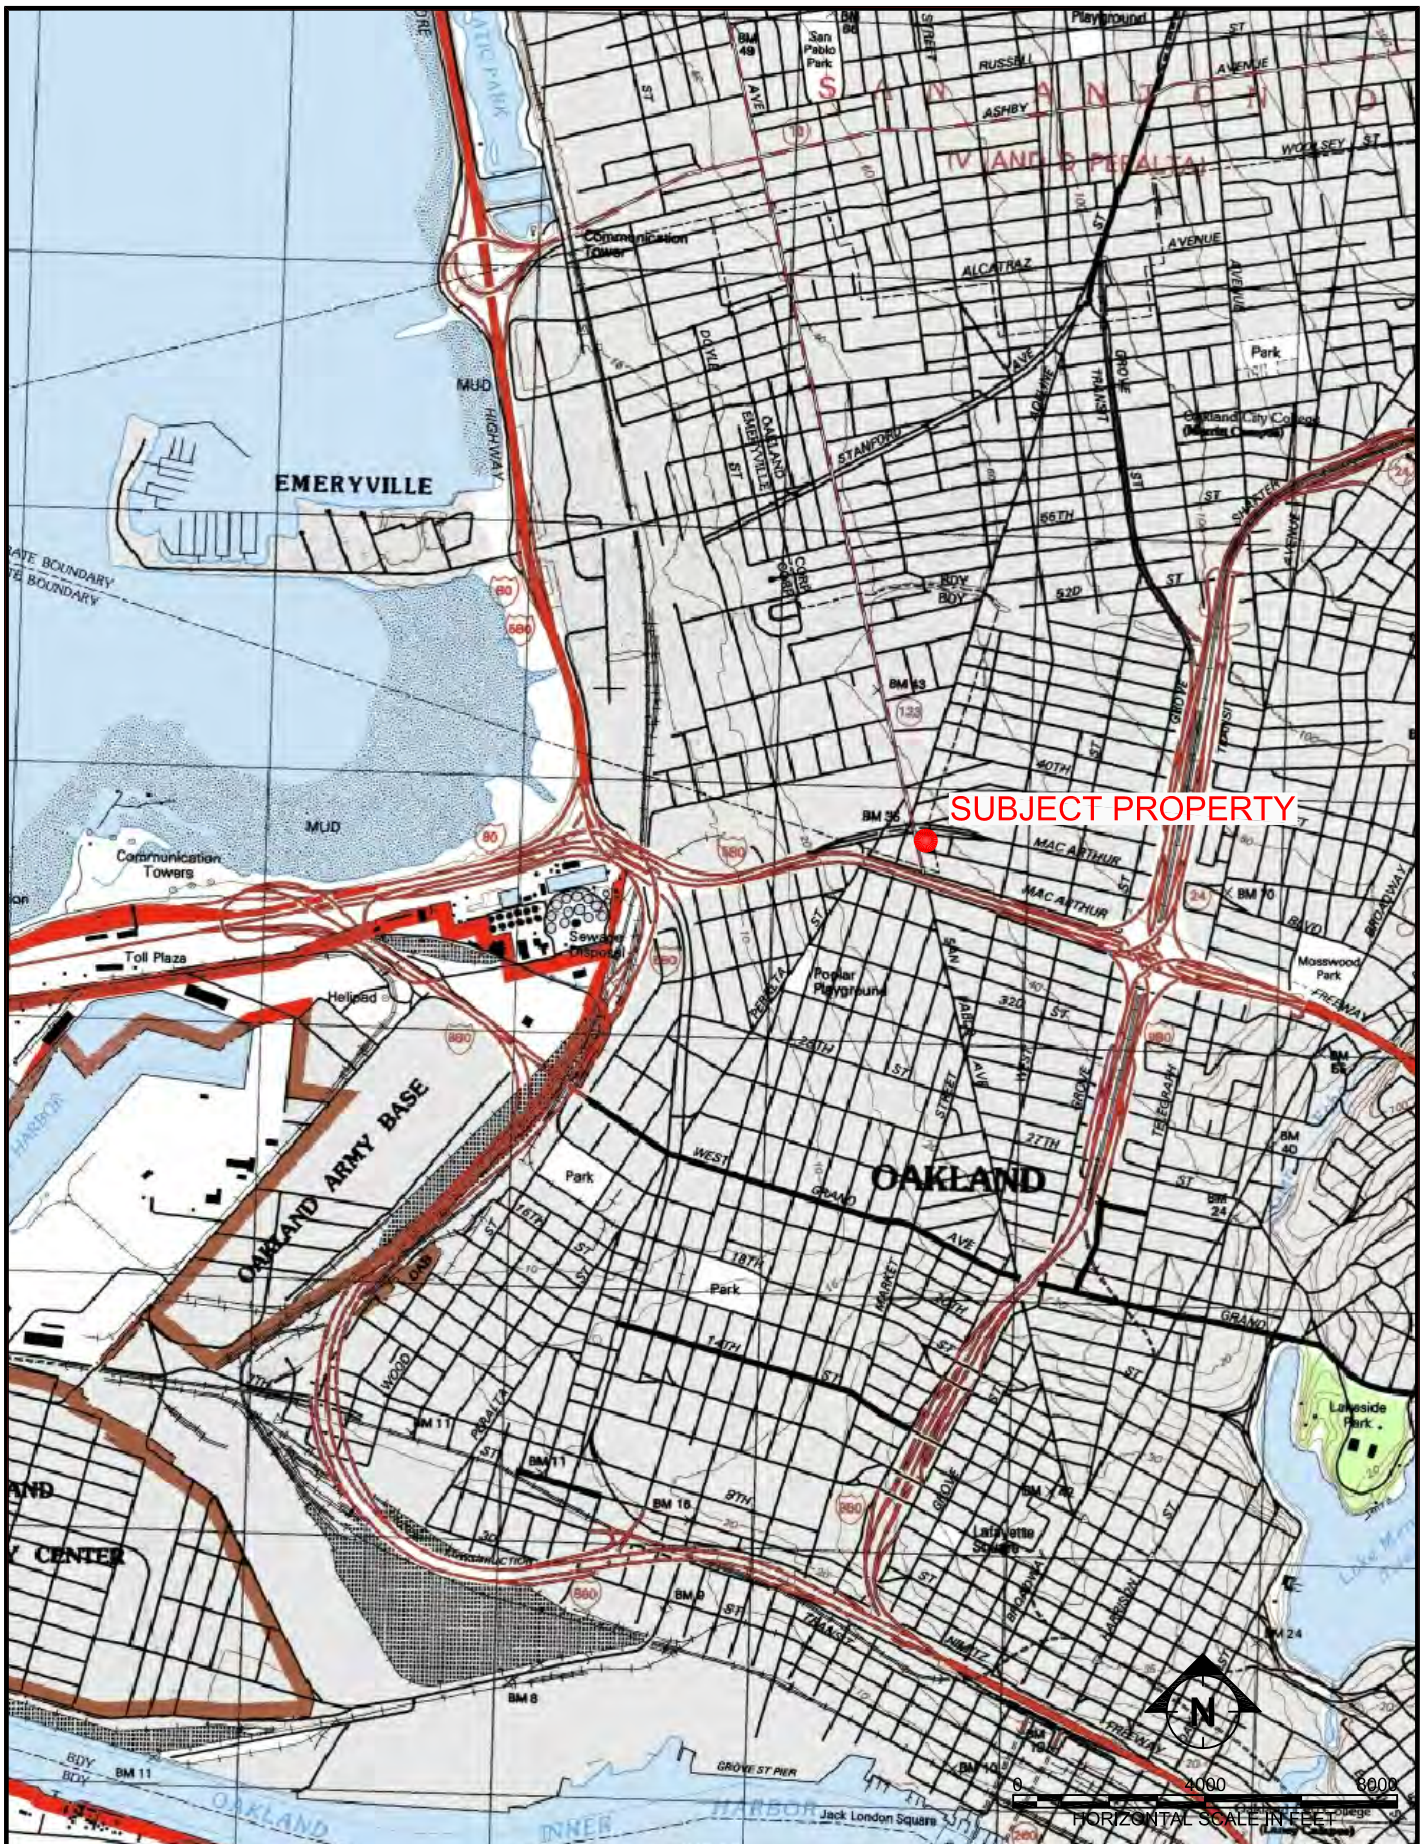
**FIGURE
 1**

EMERYVILLE REDEVELOPMENT
 PROJECT AREA
 EMERYVILLE, CALIFORNIA

This report presents the findings of a Phase I Environmental Site Assessment (ESA) conducted by The Source Group, Inc. (SGI) for the City of Emeryville Economic Development and Housing Department regarding the land area located at 3706 San Pablo Avenue and 1066-1072 37th Street in Emeryville, California and 1025 W. MacArthur Boulevard in Emeryville and Oakland, California (Subject Property, Figure 1).

The Subject Property is located both within the City of Emeryville and the City of Oakland (Figure 1). The Subject Property is comprised of five parcels (Assessor's Parcel Numbers: 049-0951-004-02, 049, 0951-005-01, 049-0951-006-01, 049-0951-007, and 012-0951-011) and encompasses an area of approximately 1 acre (Figures 1 and 2).

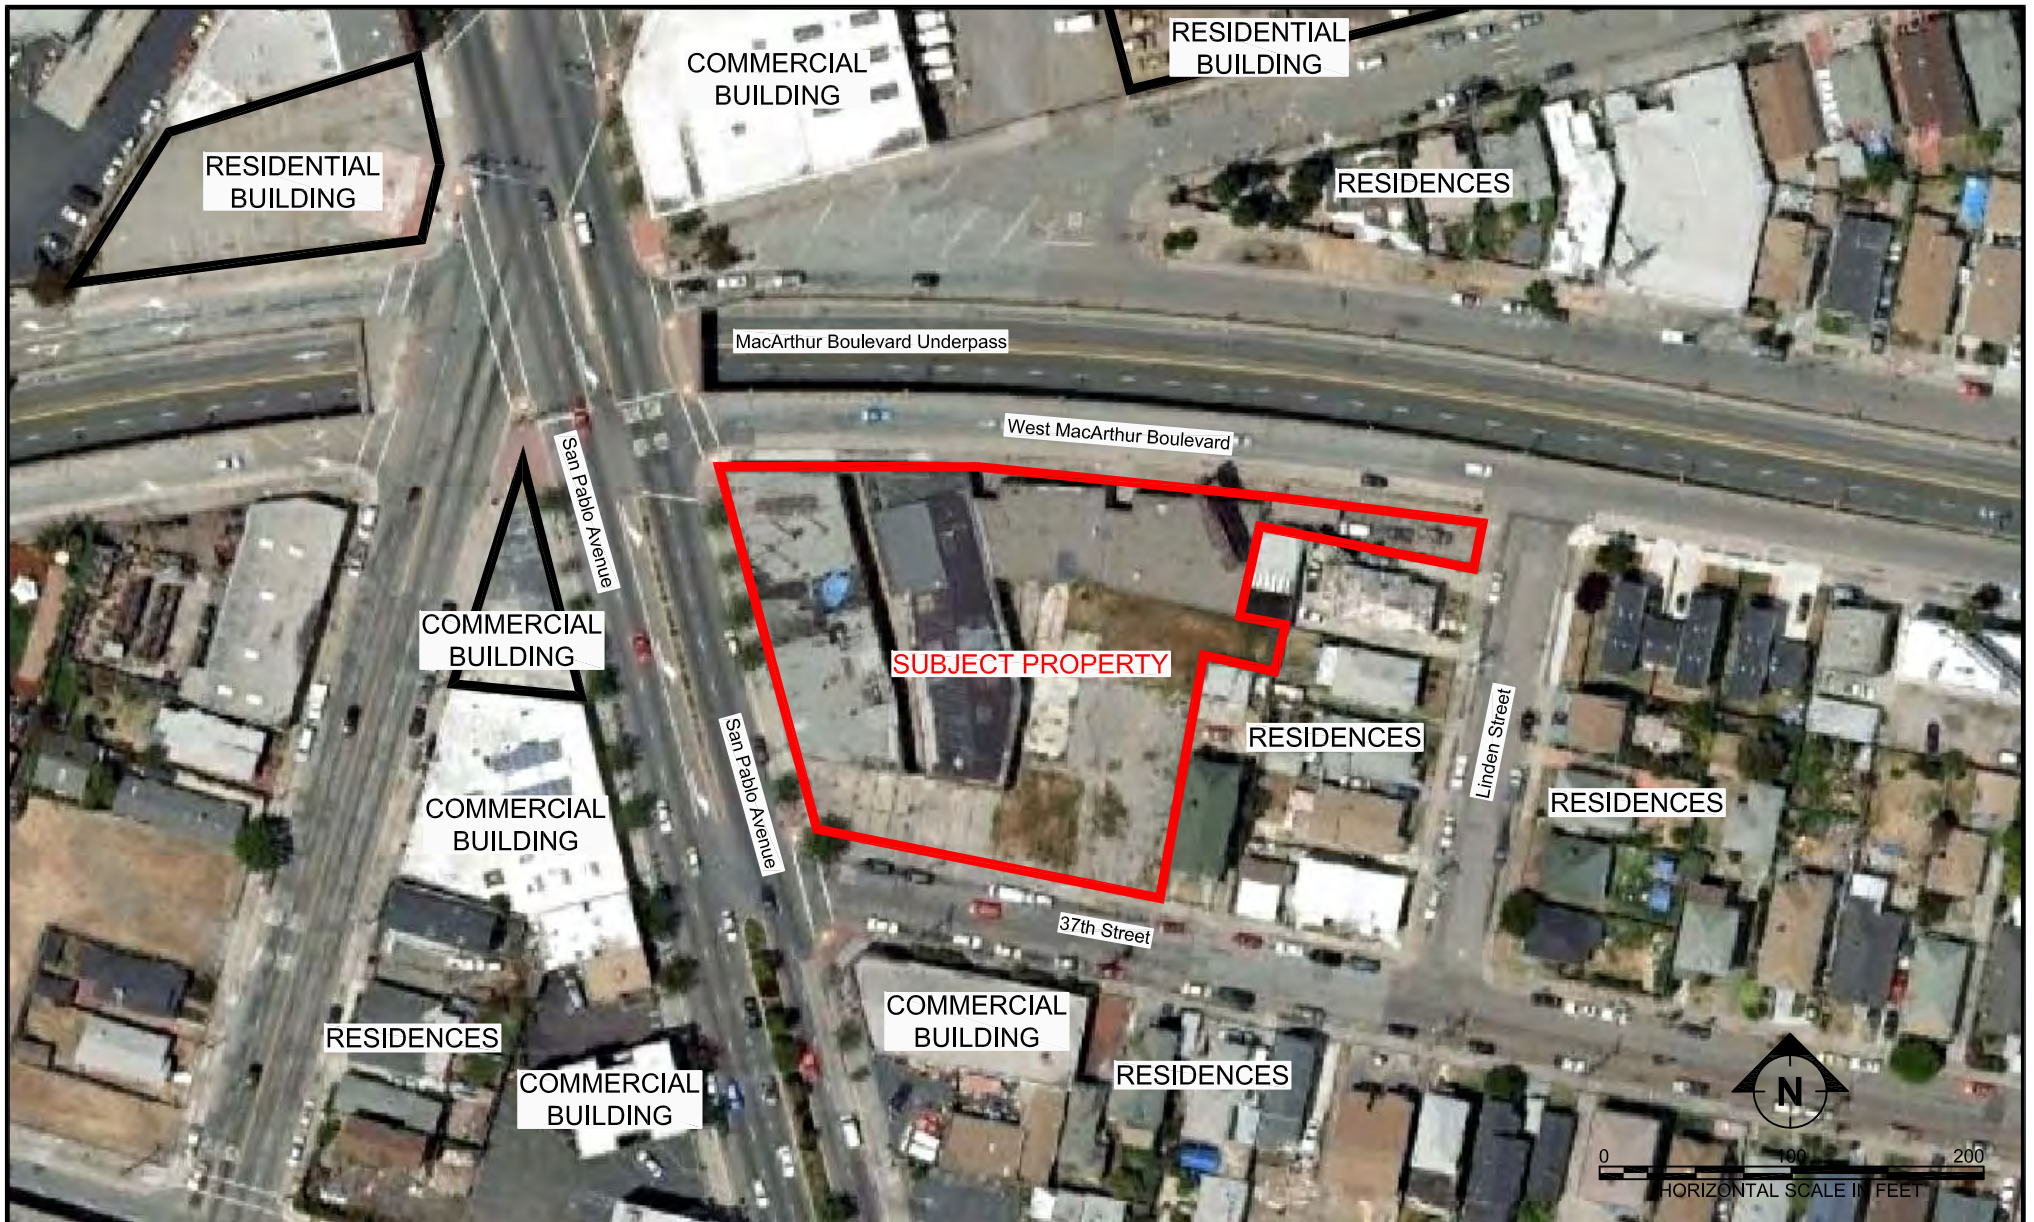
FIGURE
2

SUBJECT PROPERTY SURROUNDING
AREA

The Subject Property is located in an area characterized as mixed commercial/residential (Figure 2). The Subject Property is bounded to the north by W. MacArthur Boulevard and the MacArthur Boulevard underpass with commercial and residential buildings beyond, to the east by residences, beyond which is Linden Street, to the south by 37th Street with commercial and residential buildings beyond, and to the west by San Pablo Avenue with commercial buildings beyond.

The Subject Property is comprised of three commercial warehouse style buildings, a small concrete paved parking lot and a large open lot with mixed paving and dirt covering (Figures 2 and 3). The first warehouse building (Building 1) is located at the western edge of the Subject Property along San Pablo Avenue. The building is wooden framed with brick walls on a concrete foundation. The interior of the building has been subdivided into seven retail shop areas. Building 1 is currently empty. There is a small basement space under the north end of Building 1 that contains an open sump. To the east of Building 1 is Building 2, which has been built parallel to Building 1. A narrow alleyway separates Building 1 from Building 2. Building 2 is wooden framed with concrete block walls on a concrete foundation. The interior is open inside with the exception of a several small rooms in the southwest corner which likely contain restroom facilities. There was no evidence that this building contained a basement. SGI was unable to gain entrance to this building, though through the windows it could be seen that the building was empty. Building 3 fronts MacArthur Boulevard and is attached to the north portion of the east edge of Building 2, though there is no passage between the two buildings. It appears to be wooden framed with brick walls on a concrete foundation. SGI was unable to enter to this building or inspect the interior through a window. The foundation of a billboard advertising sign is directly adjacent to Building 3, and the billboard sign itself extends over its roof. The sign should not be considered as included within the Subject Property.

The Subject Property is located in an area characterized as mixed residential and commercial (Figure 2). The Subject Property is bounded to the north by MacArthur Boulevard with residential buildings beyond, to the east by more residential structures beyond which is Linden Street, to the south by 37th Street with mixed commercial and residential buildings beyond, and to the west by San Pablo Avenue with commercial buildings beyond.
